Buchans Ecological Engineering Treatment Assessment

Long-term performance evaluation and Site Visit Report (2009)

Margarete Kalin

October 2009

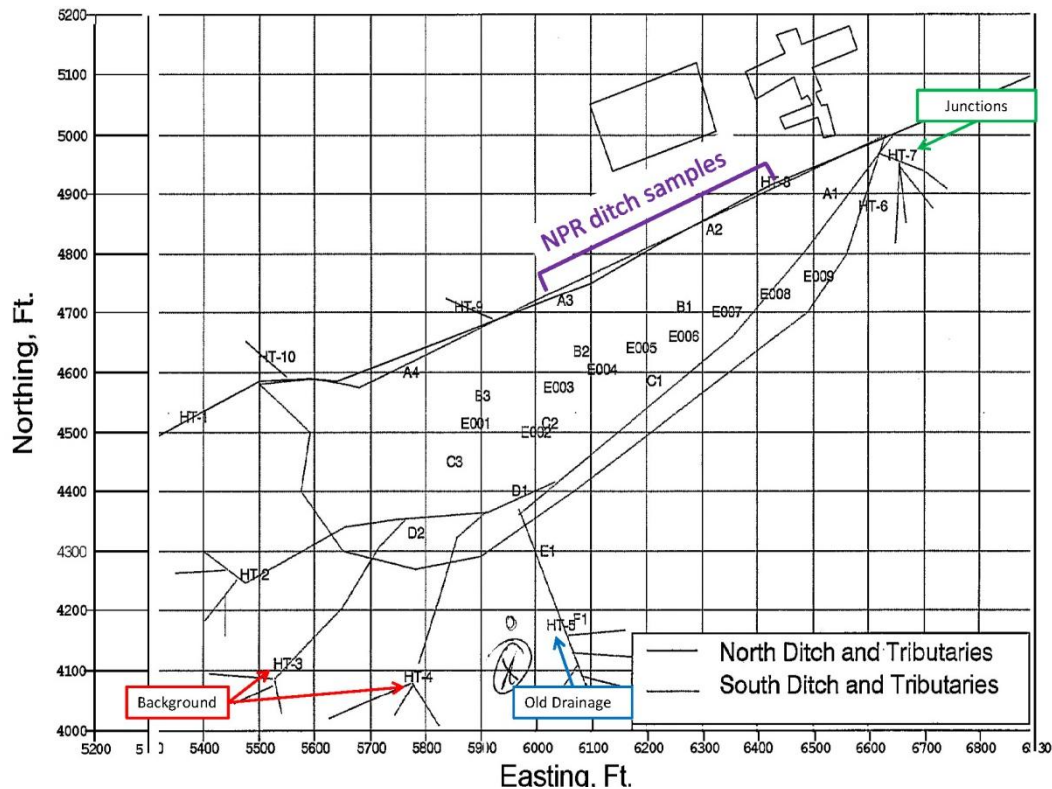
Figure 1. Buchans Hospital tailings Sampling Locations

The sampling grid of the pits dug in 1994 in the area of the Hospital tailings also referred to as the Mucky Ditch indicate the sampling locations (Figure 1, source AB046 page 19). The locations where measurements were carried out in 2009 are indicated in colored boxes, **lilac** for the PHITO ditch, **red** for the background *i.e.* uncontaminated, **blue** the old tailings drainage, now receiving overflow from the new barite tailings ponds and **green** the location of the junction of the fresh water diversion ditch with the PHITO ditch. Water samples are with Dr. S. Alam, Department of Civil Engineering at Memorial University.

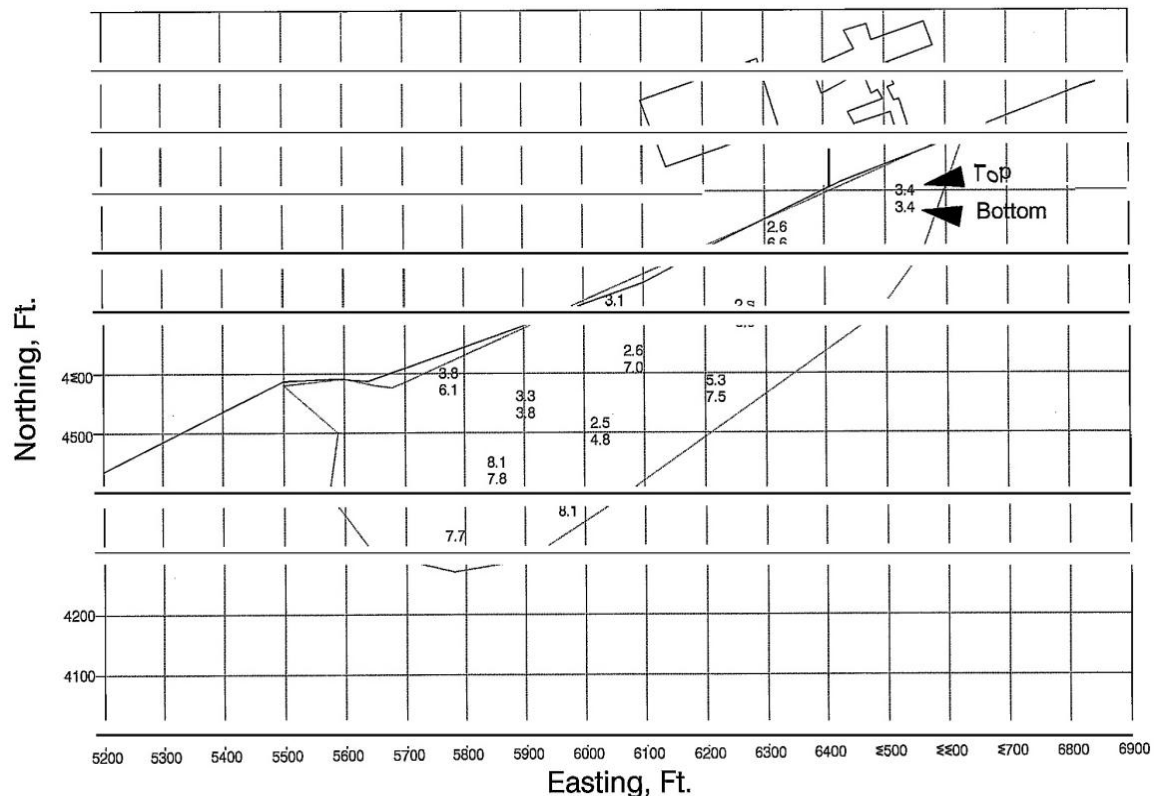
Figure 3. Buchans Hospital Area Tailings slurry pH values surface and bottom (1994)

The pH value distribution of the surface and the bottom samples in the investigated area in 1994 (Figure 3) were used to determine the location of the fresh water diversion ditch, as higher pH values were recorded on the grid around 4400 Northing and 6200 Easting.

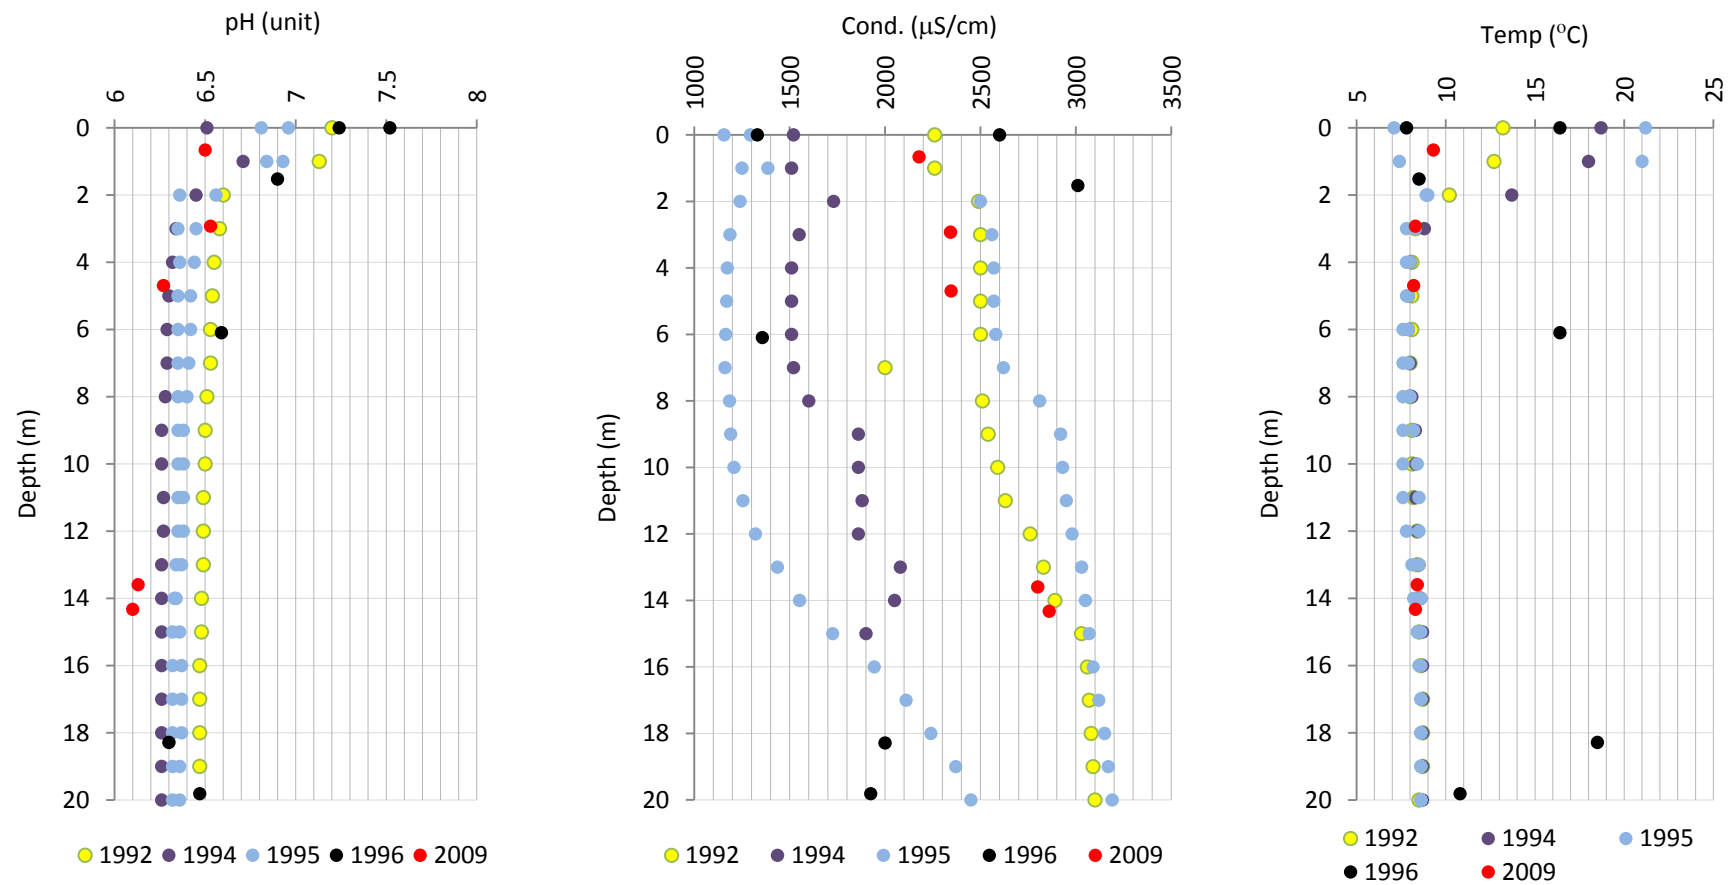
Figure 5. OEP pH, Conductivity and Temperature profile measurements between 1992 and in 2009

As Eh readings are seasonal, all available profiles measurements from the past are plotted in Figure 5 and 6, such that the potentially acidifying trend (drop in 1 pH unit) can be supported by a larger data set. The electrical conductivity has remained the same and also the temperature is within the same range as previously measured. Dissolved oxygen was unfortunately not recorded in 2009 but would be expected to be lower, given the Eh, which has clearly decreased.

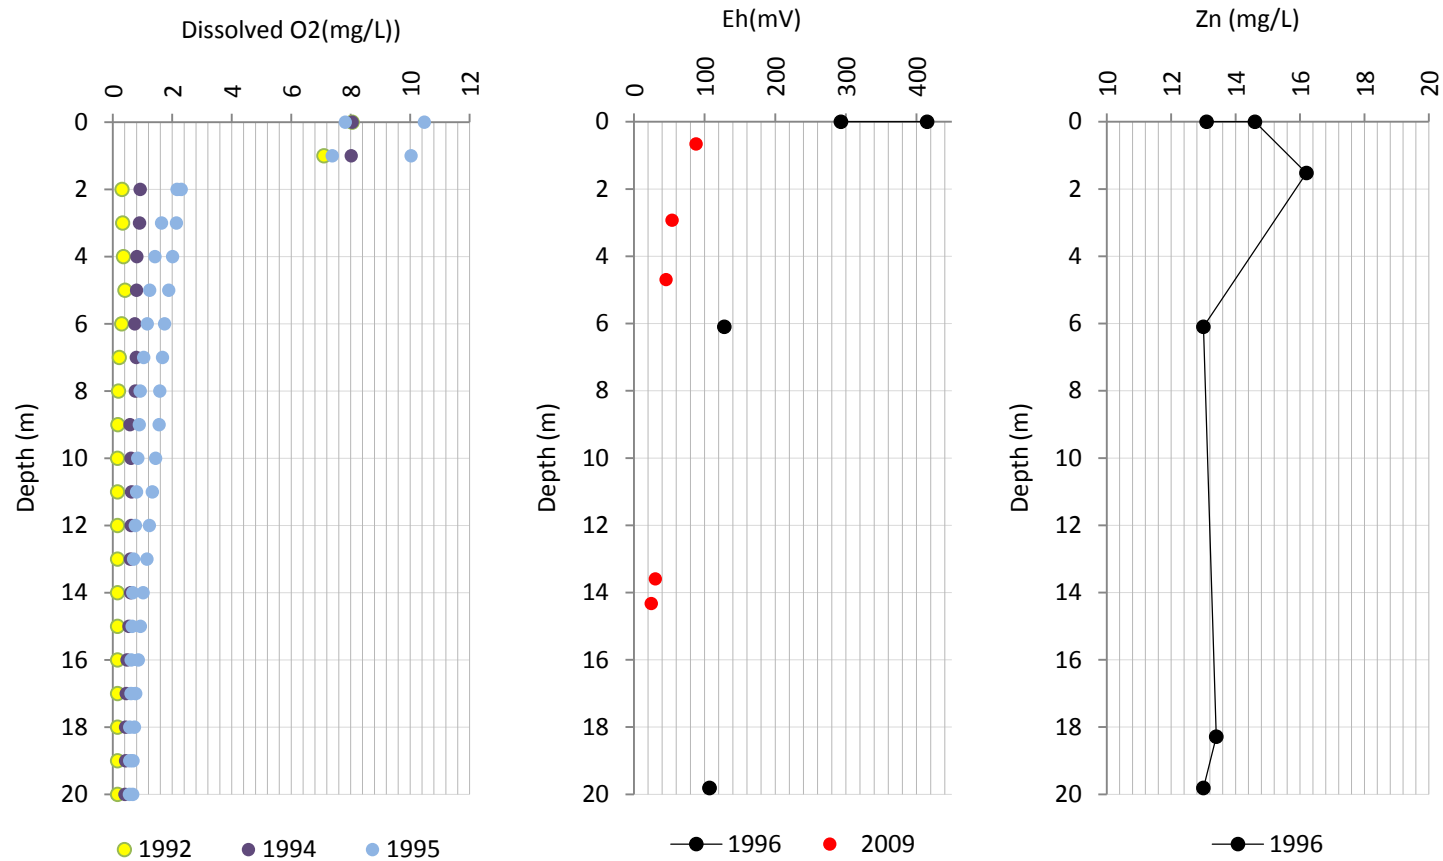
Figure 6. OEP Dissolved oxygen profile measurements between 1992 and 1995, Eh comparison between 1996 and 2009 measurements; OEP Zn concentration in 1996

Given the driver of the zinc removal process is the oxidation of iron, it is essential that the Eh values are between 300-400 mV. The last measurements of these parameters were made in 1996 and they are given with the values measured during the site visit in Table 3. The pH values on the surface are about 1 unit lower in 2009 and the Eh values are reflecting lower Eh conditions.

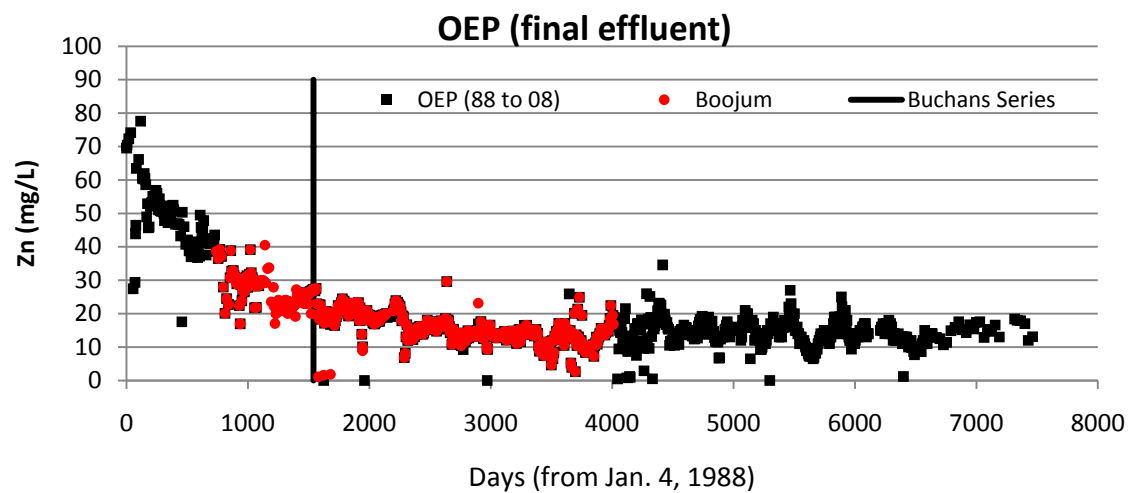
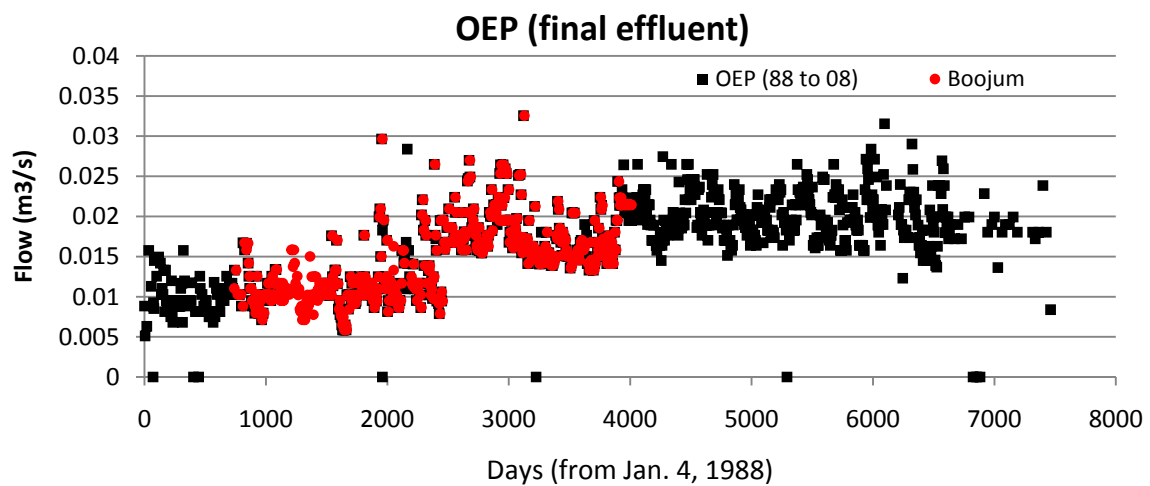
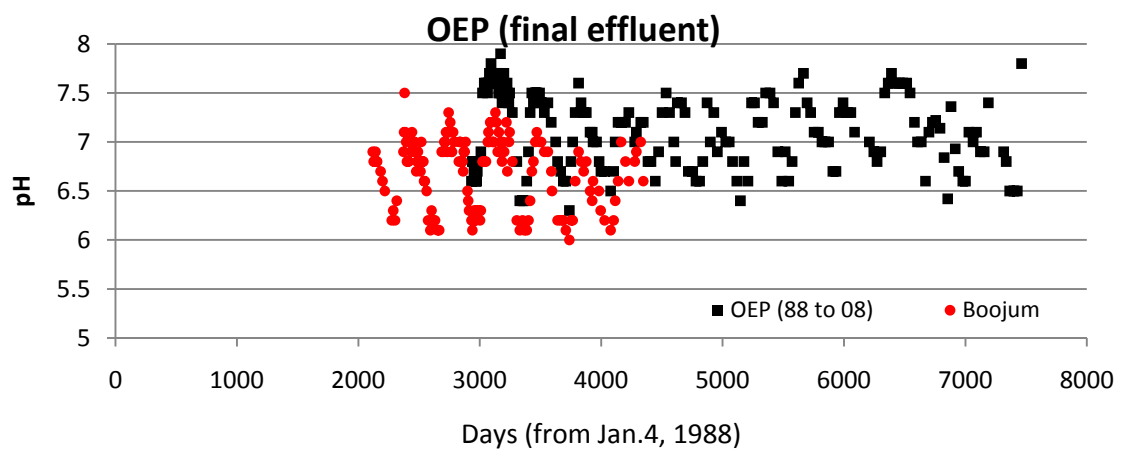
Figure 7. OEP Performance (1988-2008)

Using the monitoring data of the OEP final effluents (Figure 7) the zinc concentration of the OEP has remained between 10 and 20 mg/l. The flows seem to be within the same range over the years and pH is also within the same range for the effluent. Thus the vertical noted acidification is unlikely of importance. However the reduction in Eh is of concern as it will hinder zinc removal. A more complete investigation of the pit limnological profiles is required along with the OWP pit .

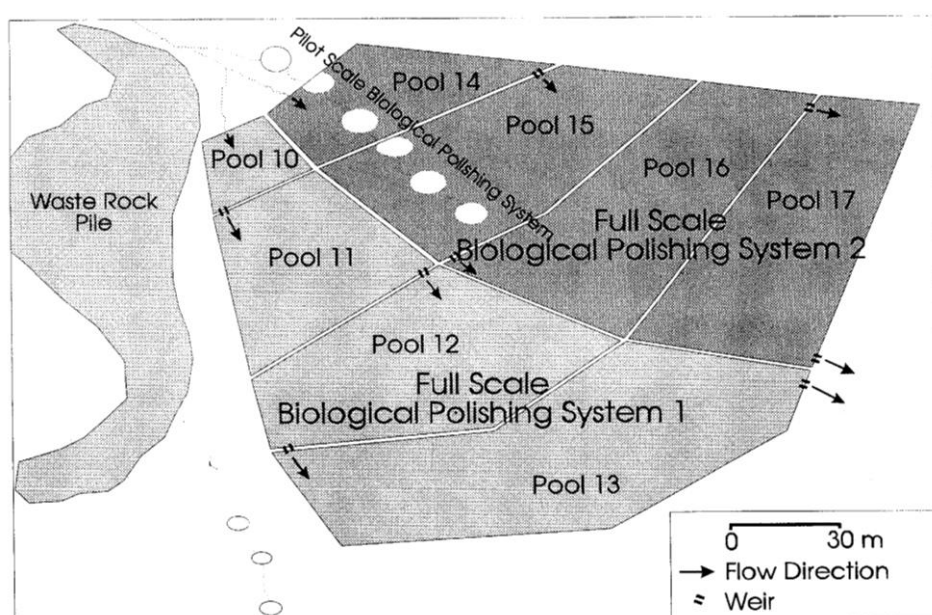
Figure 8. Layout of Biological Polishing Ponds 10 through 13 (Biological system 1) and 14 to 17 (Biological system 2).

The layout of the polishing ponds is given in Figure 8. The same numbering system has been used to assess the polishing ponds. The two systems work in parallel as the effluent from the OEP are split and should enter the same amount of water to both sides. This is no longer the case, as pool 10 receives considerably less water than pool 14.

In system 2, (14 inflow to 17 outflow) the inflow has the highest redox reported of the entire system, both at the weir edge and at the bottom. All other pools have a low redox or Eh value.

From visual observations the algal populations are not as extensive as they were previously, which also reduces the oxygen production by the algae, reducing the zinc removal. As the ponds were cleared out, much of the brush has been removed, which was unavoidable, but hinders removal of the contaminants. It is not clear what motivated the clearing of the pools.

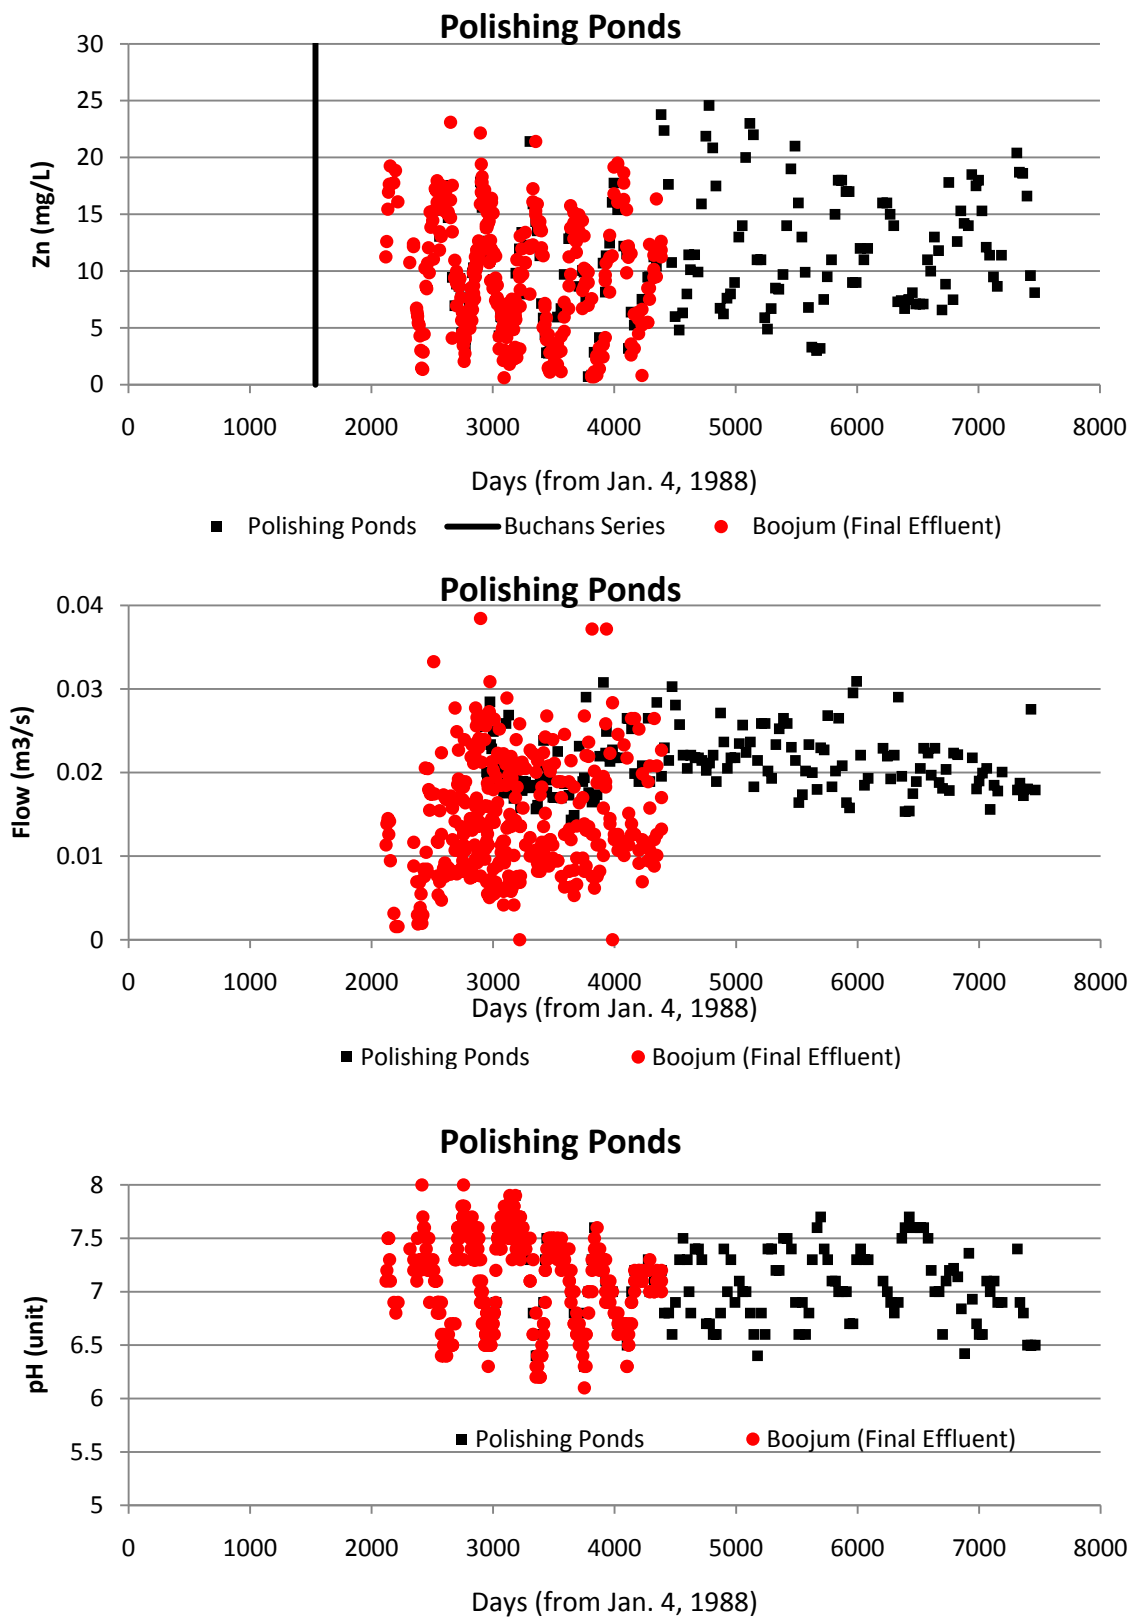
Figure 9. Polishing Ponds performance (1993-2008) (Final Boojum effluent corresponds to Pool 13 and 17)

In Figure 9, the performance of the final effluents of the polishing system is given. The initial seasonal fluctuations are very pronounced up to day 5700 or August 2003. It is evident that the summer low concentrations are decreasing from that time on. This is likely a reflection of the reduced oxidation capacity of the system. Apparently sugar was added at the pumping station at one point in time. This addition had likely little effect in the pond performance as sugar is water soluble and would have left the system within days. The flows to the system have remained the same since Boojum worked there (see Fig 9). The initial large variations in the flows were due to the gradual additions of additional effluent streams up the 1999.

Further additions were reported to have been made to the OWP and the OEP in the form of biosolids. This was likely quite destructive to removal as these solids promote microbial iron reduction. This will take place initially rather rapid , due to the easily degradable carbon utilized by iron reducing microbes followed by a slower phase as the recalcitrant or hard to degrade carbon will have its effect in the long term.

From our perspective, the system can be easily brought back to its original performance and we would welcome to cooperate with any interested party. Most economically, the work could be achieved with a local contractor after a full investigation of the entire flow system.

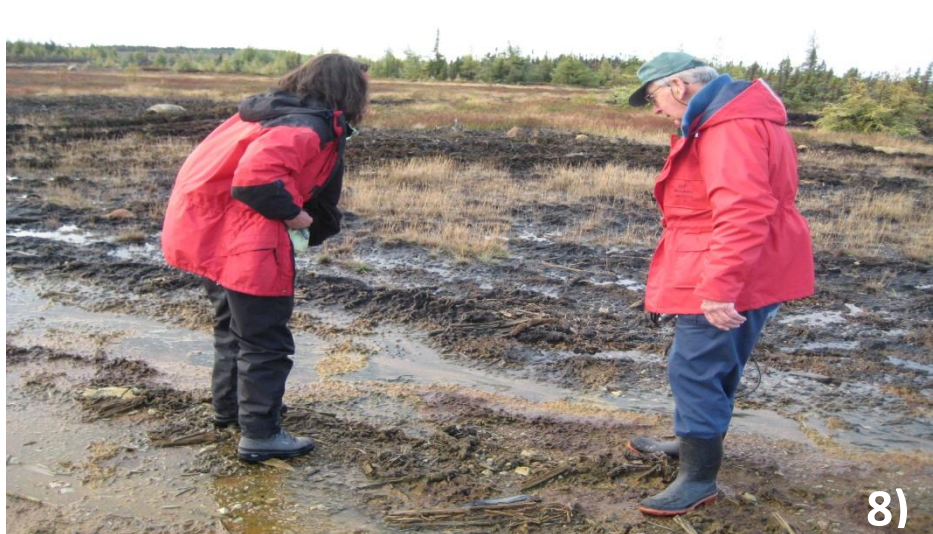
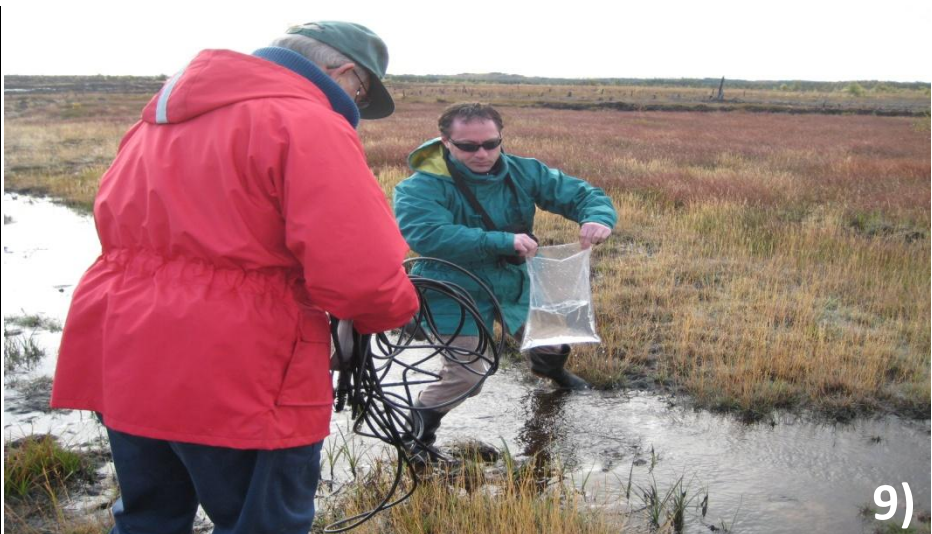
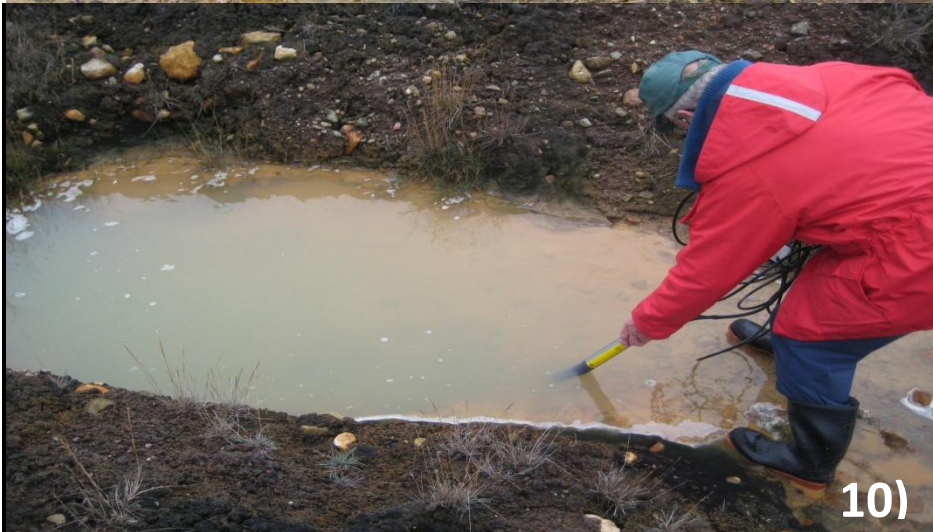
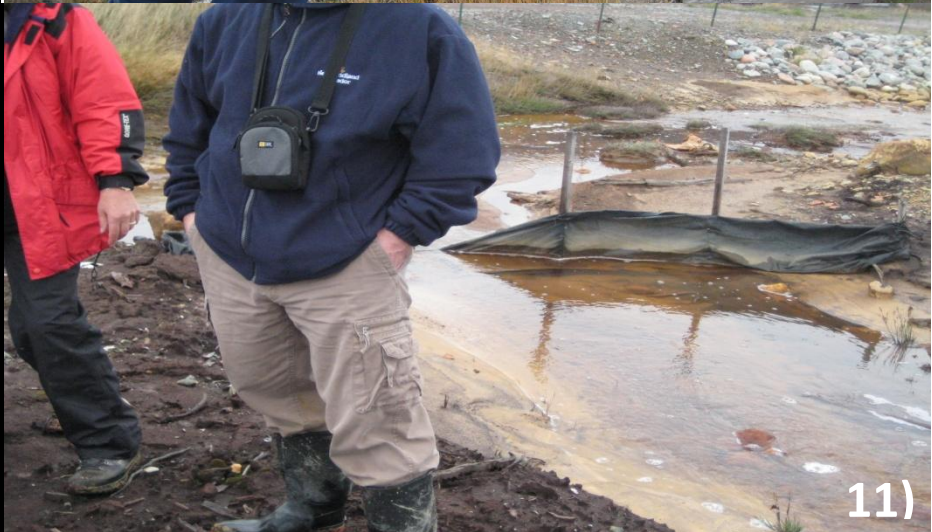
Plate 3. 8), 9) and 10) diversion ditch; 11) Diversion ditch before junction with NPR ditch.

The chemical analysis of water and solid samples collected from the ditch lining would have to be obtained in addition to solid samples from the lining. However the application certainly has halted any erosion from the ditch. The banks are well covered with vegetation the lined ditch (see Plate 12 appendix)and the unlined fresh water diversion ditch for comparison (see Plate 8 appendix).
